**Commercial
Roofing
Consultants, Inc.**

LIMITED ROOF SURVEY

PHOEBE PARK ASSOCIATION

August 23, 2010

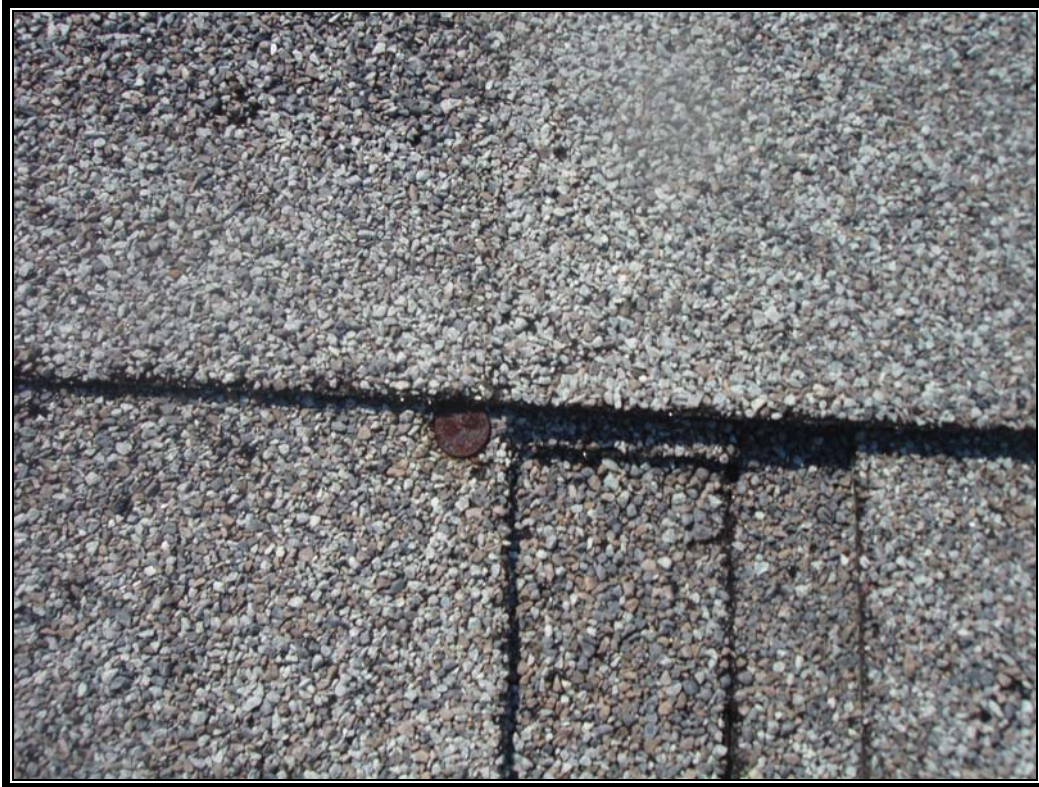
PHOTO #3: EXPOSED FASTENER – TYPICAL

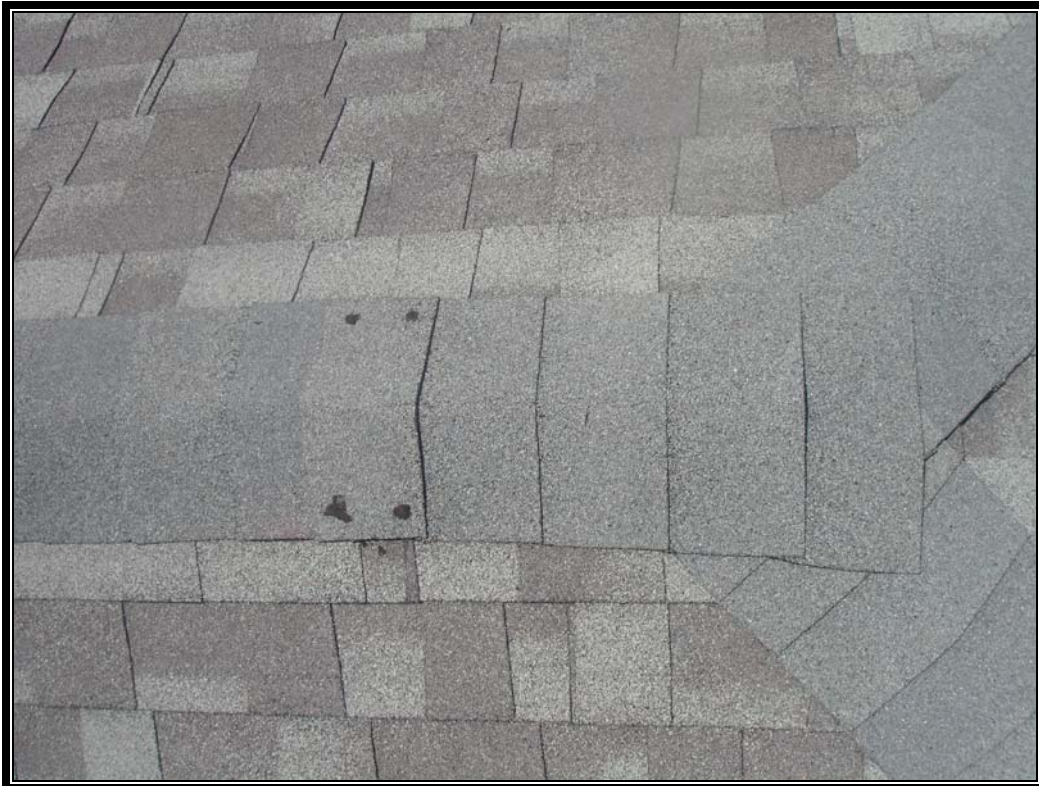
PHOTO #4: EXPOSED FASTENER - TYPICAL
